Appendix 10.4: Peat Management Plan

# **Mullaghclogher Wind Farm**

## **Renewable Energy Systems Ltd**

SLR Project No.: 428.011231.00001

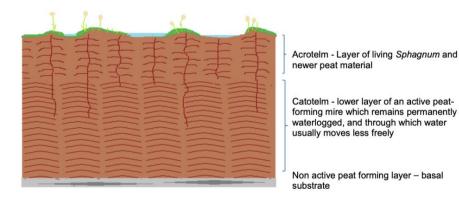
#### Plate 1-1: Drawing of two layered Structure of Active Bog Peatlands above Non-Active Peat

Peat can be classed as two principal types, the acrotelm layer, and the catotelm layer as shown on **Plate 1-1**.

The acrotelm layer is found in the upper layer of peat where conditions are relatively dry and comprises living vegetation and partially decomposed plant material. Hydraulic conductivity in this layer tends to be higher in relation to distance from the water table. The thickness of the acrotelm layer varies depending on topography such as steepness of slope, peat hags, and hummocks. In particular, the acrotelm layer can be affected during periods of drought or as a consequence of drainage. Fibrous in texture, the acrotelm layer has some tensile strength and is generally considered to be stable for storage and re-use.

The catotelm layer is found under the acrotelm layer and comprises decayed plant material and organisms and is denser and with a very low hydraulic conductivity. The catotelm layer sits below the water table resulting in permanent anaerobic conditions. The catotelm layer is amorphous and has very low tensile strength making it less suitable for storage and re-use.

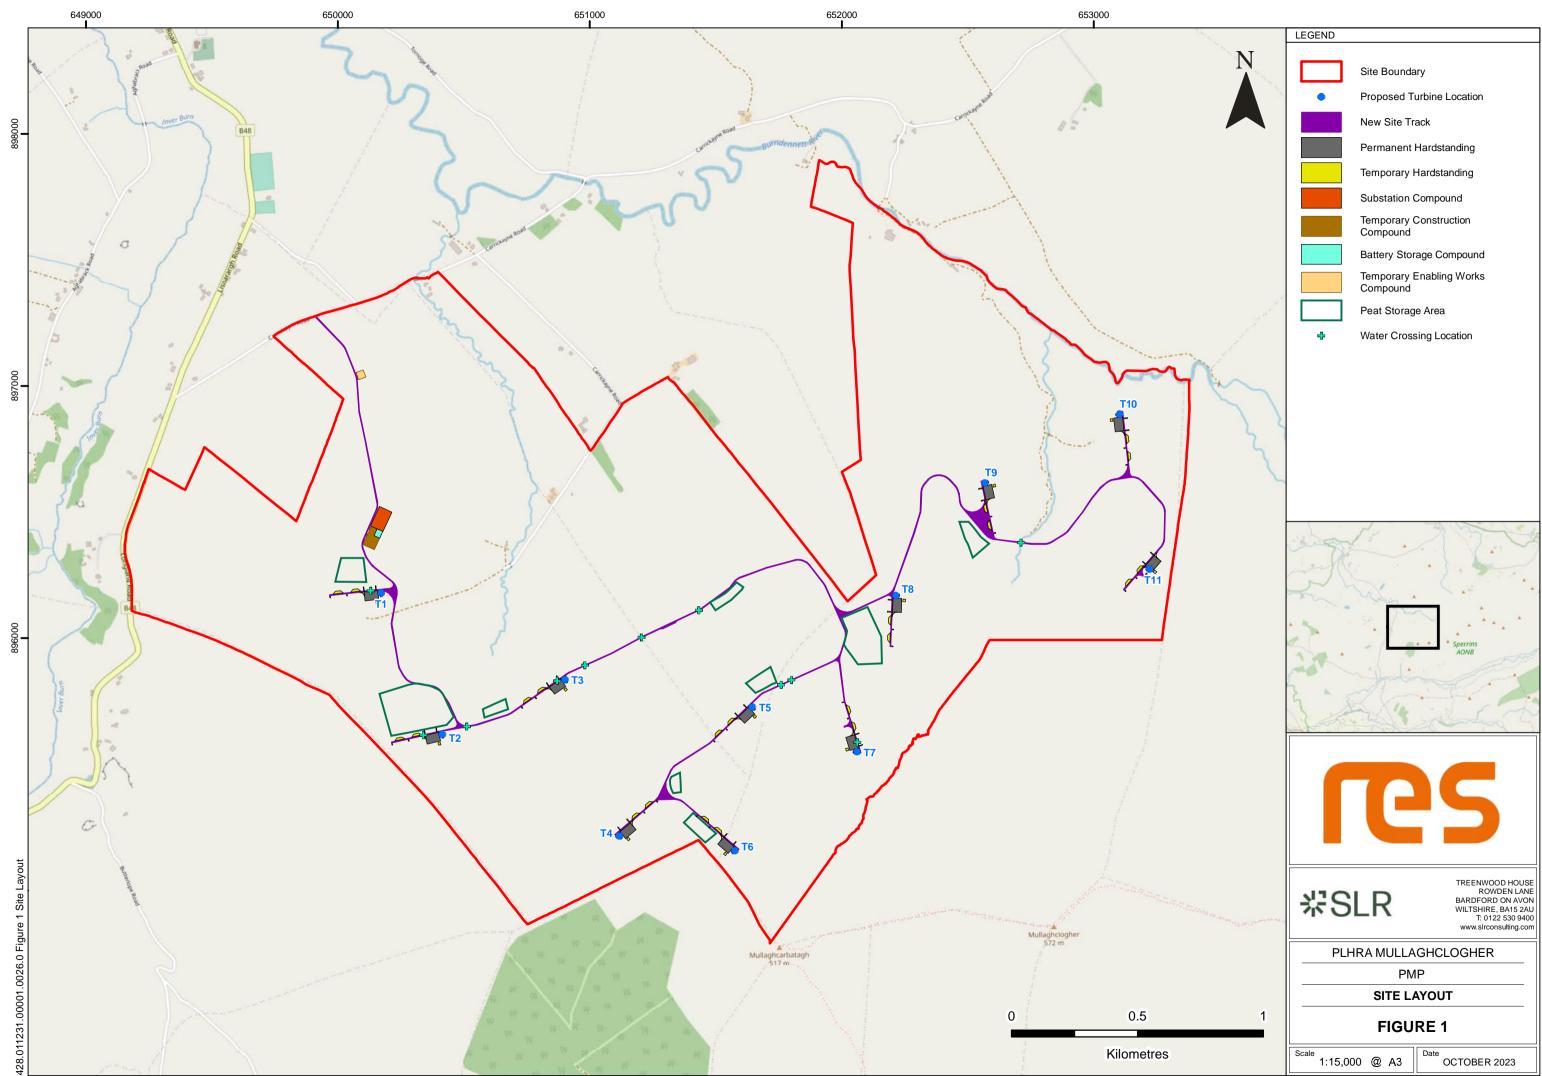
Full details of the Proposed Development are provided in Chapter 2: Proposed Development of the EIA Report. The location and layout of the red line boundary which define "the Site" are detailed in Figure 1.

The Proposed Development is an area of approximately 615 Hectares (Ha), located approximately 4km North East of Plumbridge, Northern Ireland, centred on National Grid Reference (NGR) of NV 659 582. The Proposed Development Location is detailed on Figure 1.

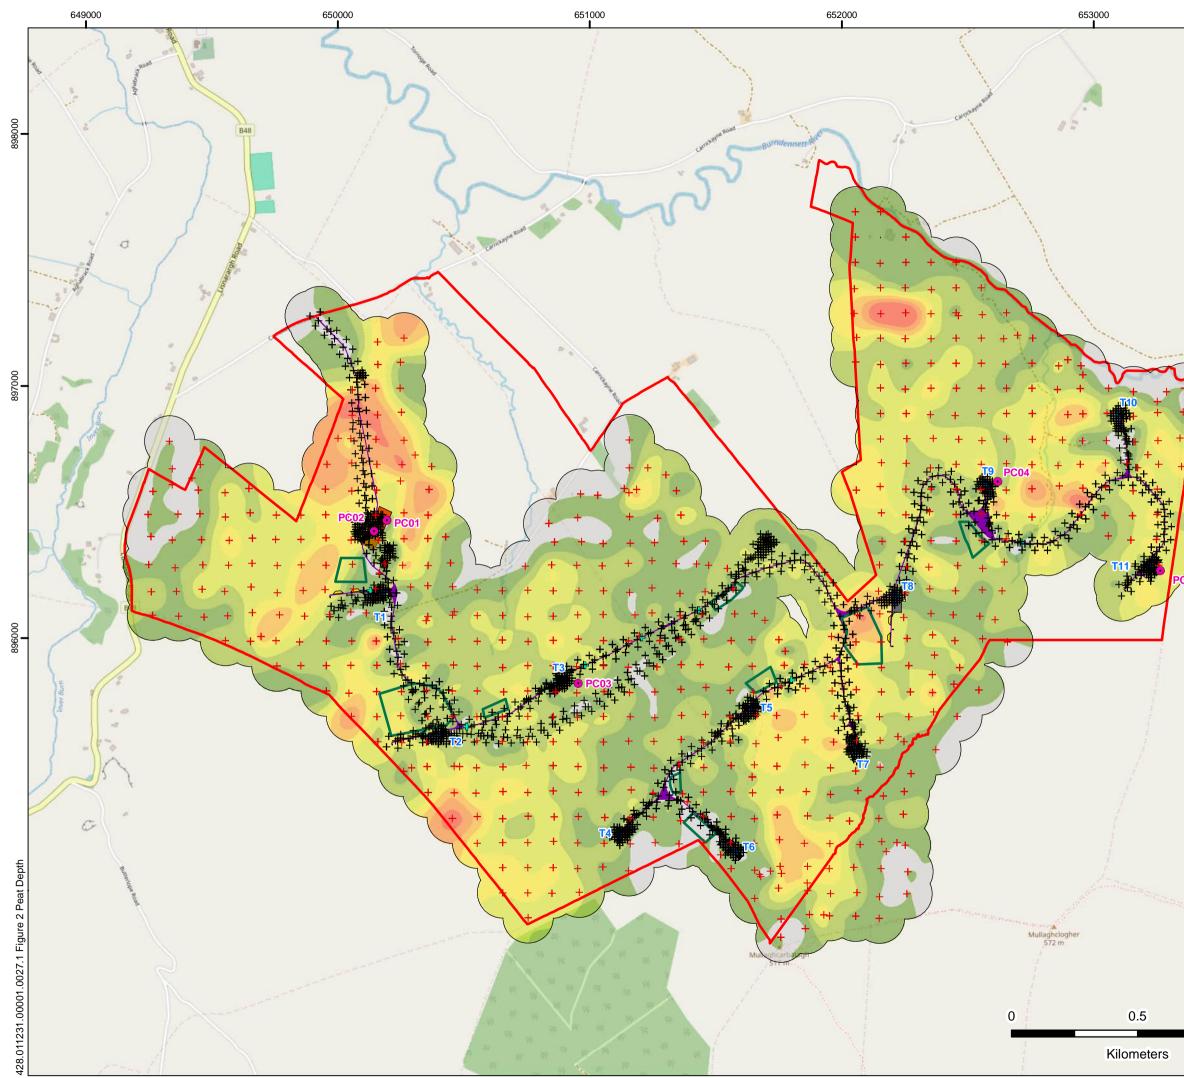
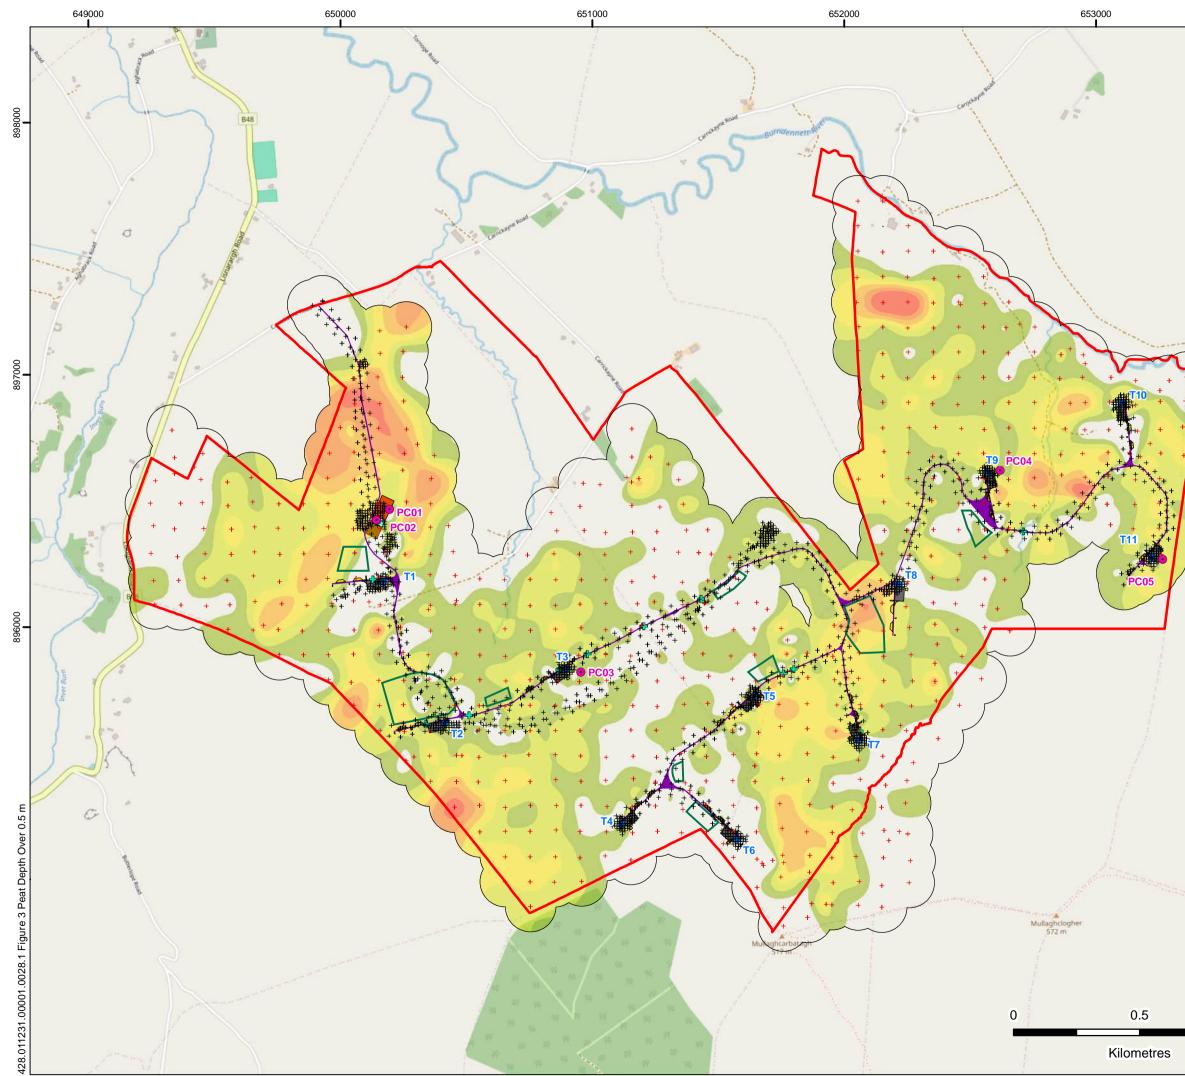
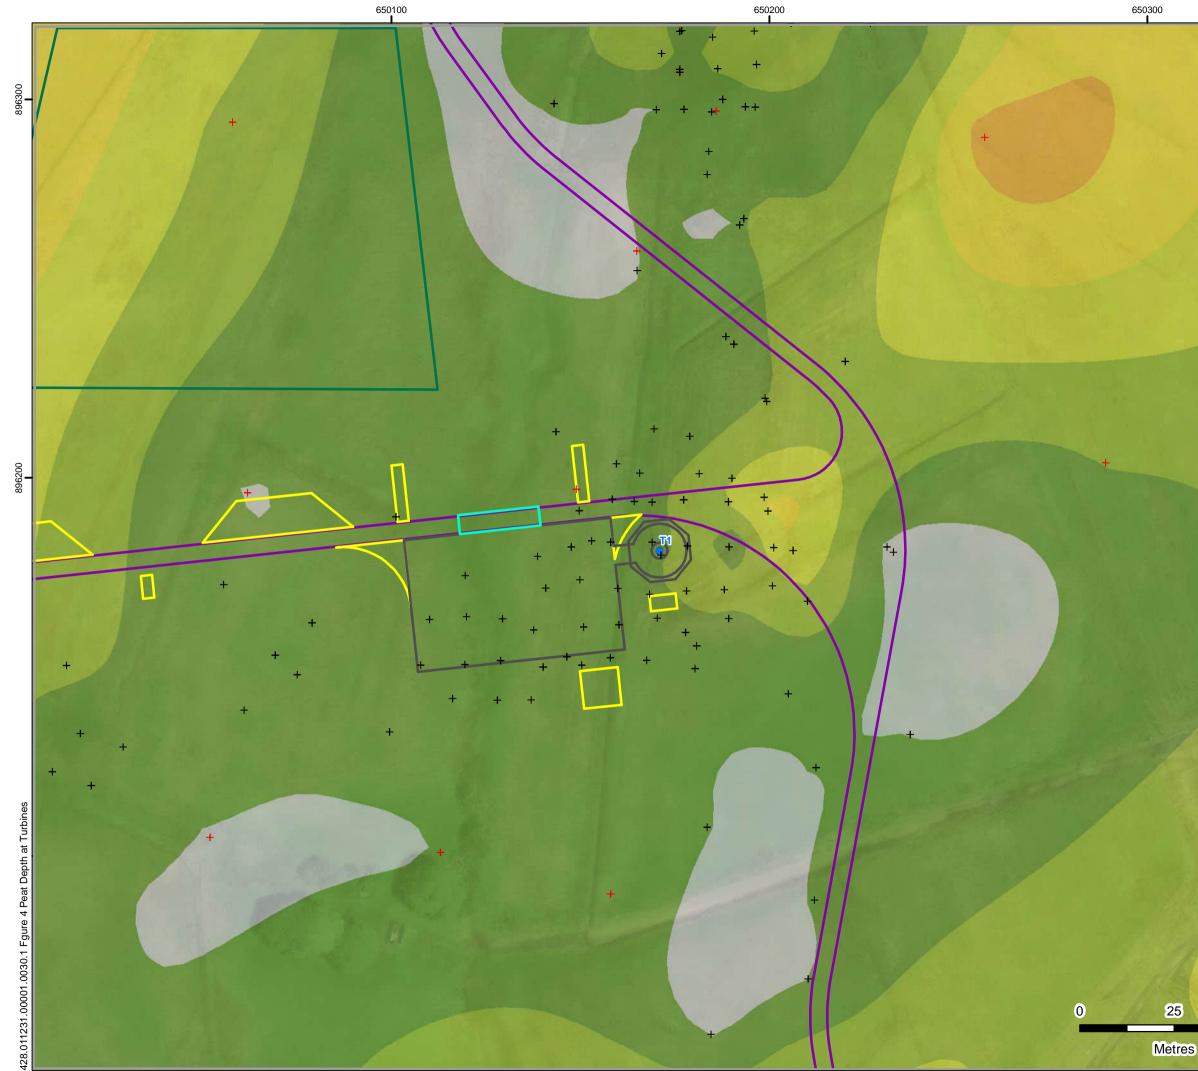
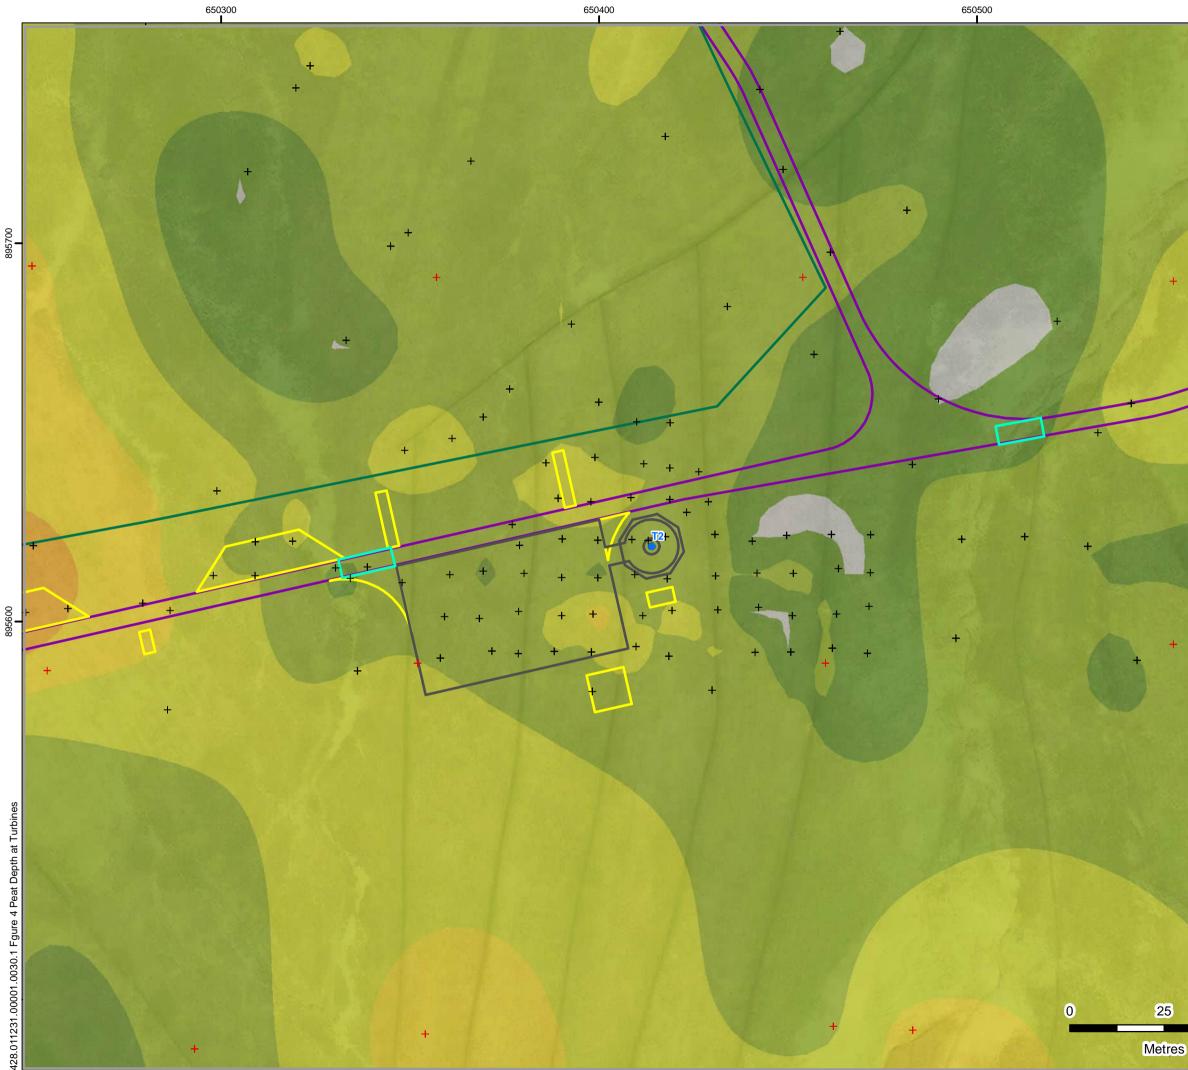
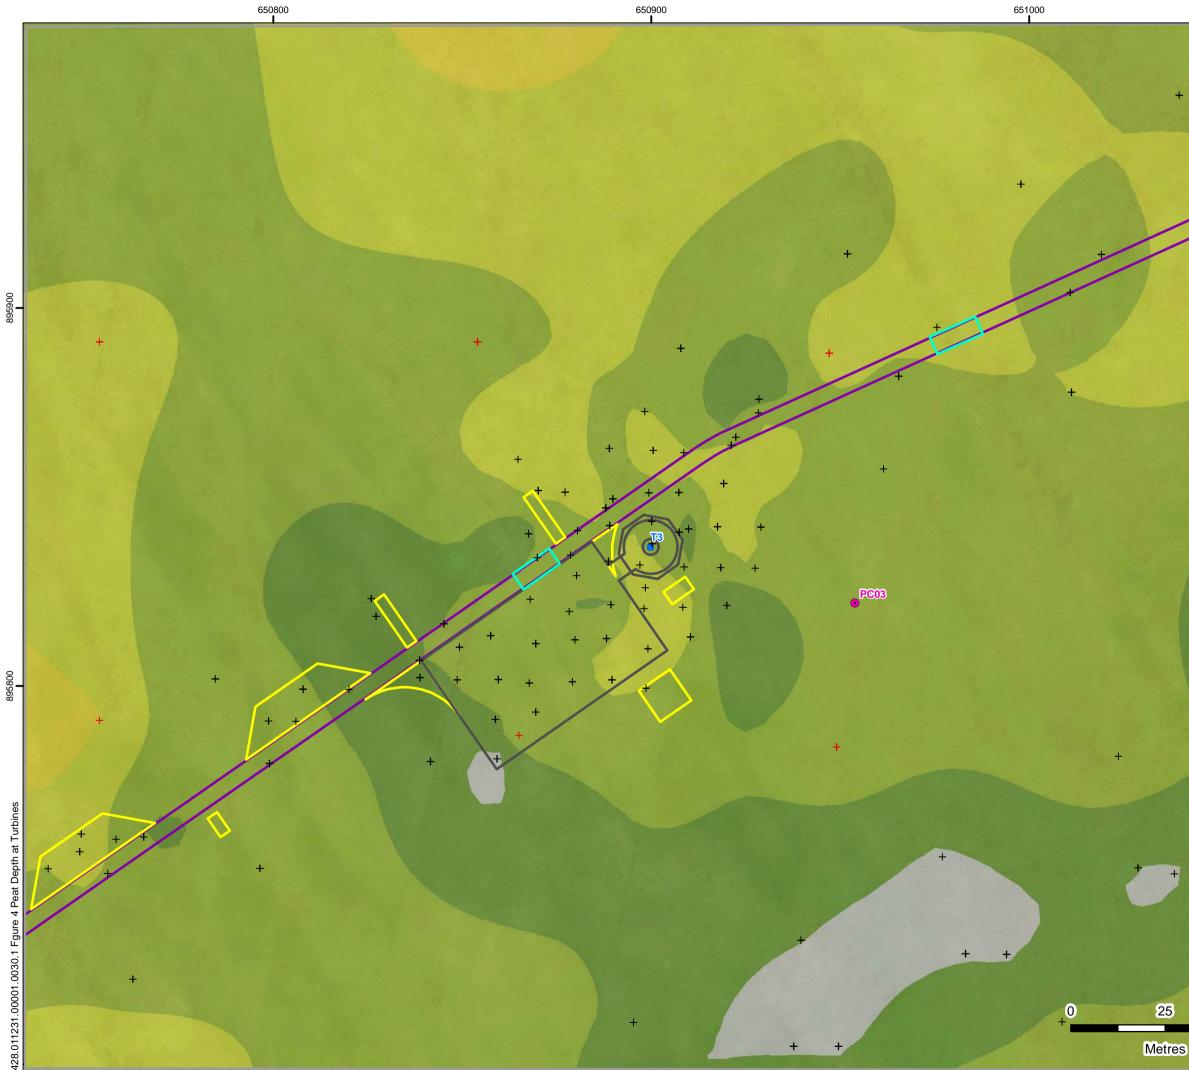
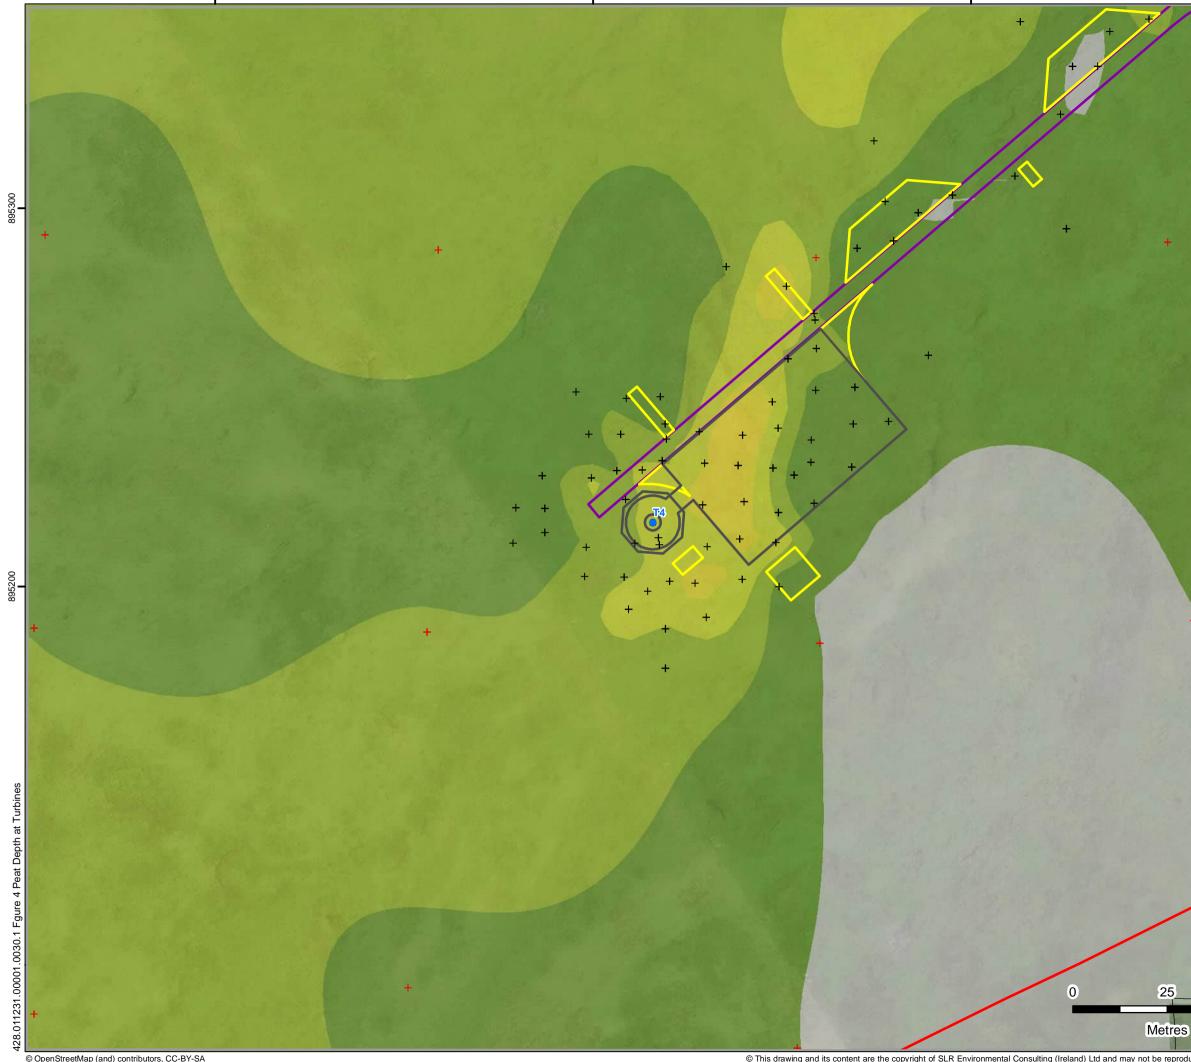
The results from all probing phases are detailed in the following sections and displayed on Figures 3 and 4. A total of 2,232 peat probes were undertaken across all survey phases, with the results summarised in Table A.

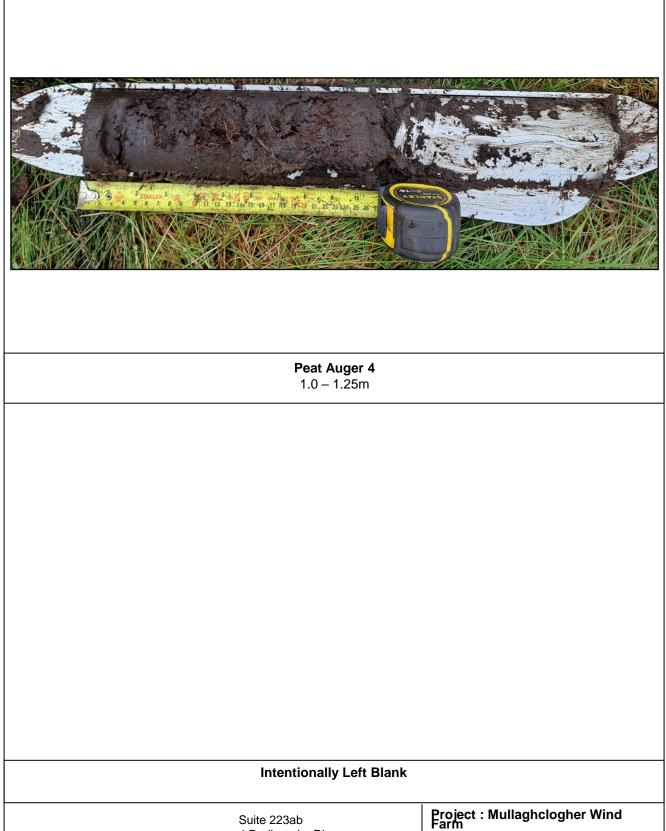
Based on field descriptions at augering points, most of the peat would be classified as between H2 and H4 in the von Post**Error! Bookmark not defined.** classification, showing insignificant to moderate decomposition.

<b>Peat Auger 4</b> 0 – 0.5m	
	0 0.011	
	<b>Peat Auger 4</b> 0.5 – 1.0m	
∜SLR	Suite 223ab 4 Redheughs Rigg South Gyle Edinburgh EH12 9DQ Tel: 0131 335 6830 Fax: 0131 335 6831 Web: www.slrconsulting.com	Project : Mullaghclogher Wind
