## Appendix 10.3: PLHRA

## Mullaghclogher Wind Farm

### Renewable Energy Systems Ltd

#### **SLR Consulting Limited**

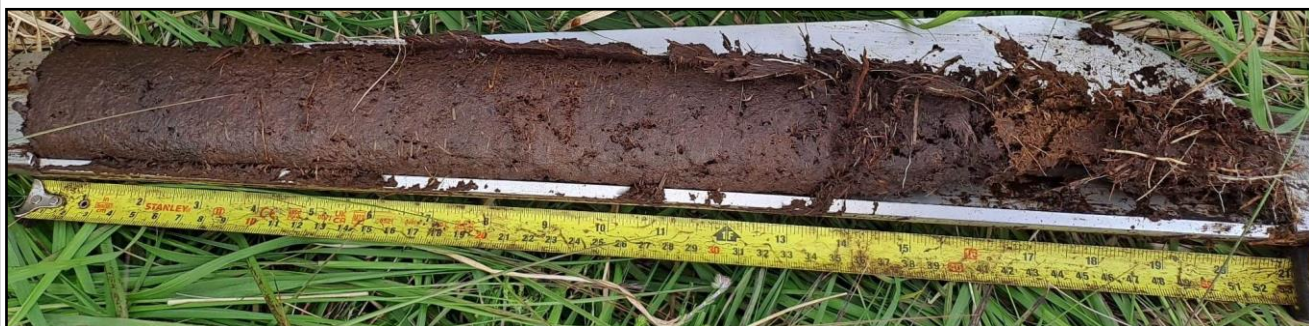
**Peat Auger 1**  
0 – 0.5m

Peat core recovered using peat sampler.
